EAST END PIPELINE REPLACEMENT PROJECT
LAND SUBJECT TO LAND OWNERS REQUEST
LOT 25 ON SP115226

PLANS AND DOCUMENTS referred to in the **SDA APPROVAL**

000-G-MAP-3314 Version 2 Date 10/10/2025

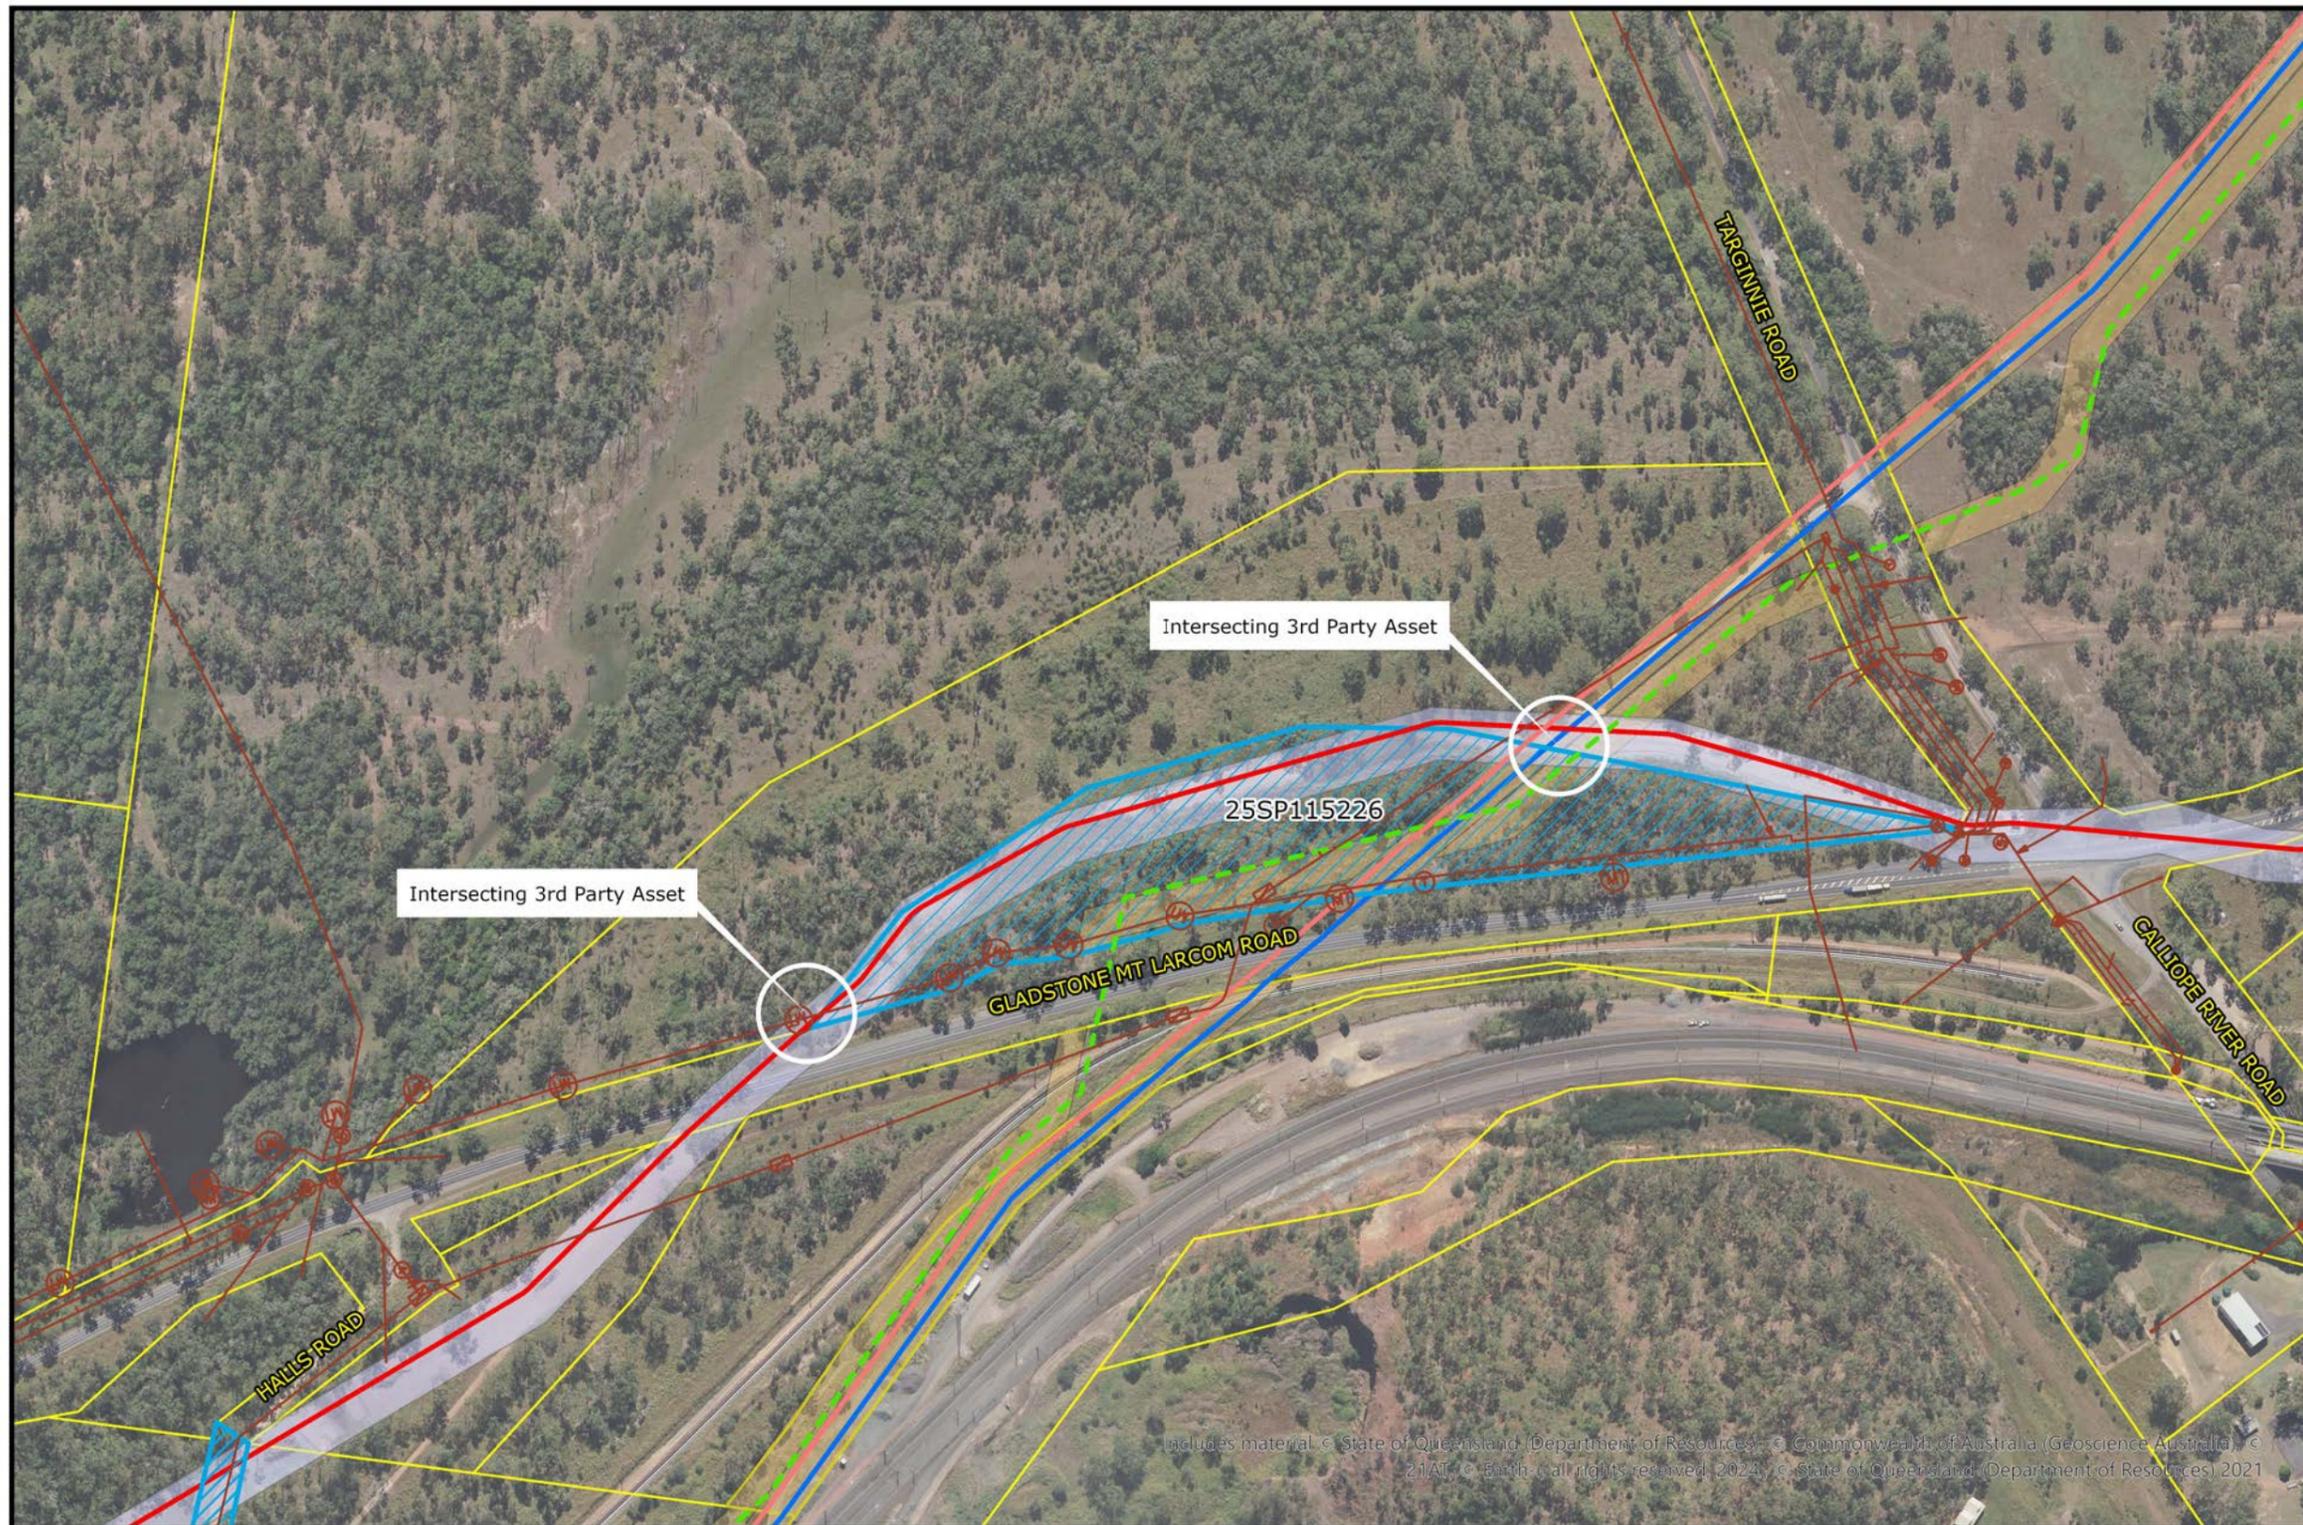
- East End Treated Water Pipeline
- Easement
- Property Boundary
- GSDA Right Of Way
- Lot 25 on SP115226
- Fitzroy Gladstone Pipeline Coexist Alignment
- - - Jemena (Gas)
- QCL Slurry Line
- Telstra Infrastructure

- Jemena (Gas)
- Queensland Cement Limited Slurry Line
- Telstra Infrastructure

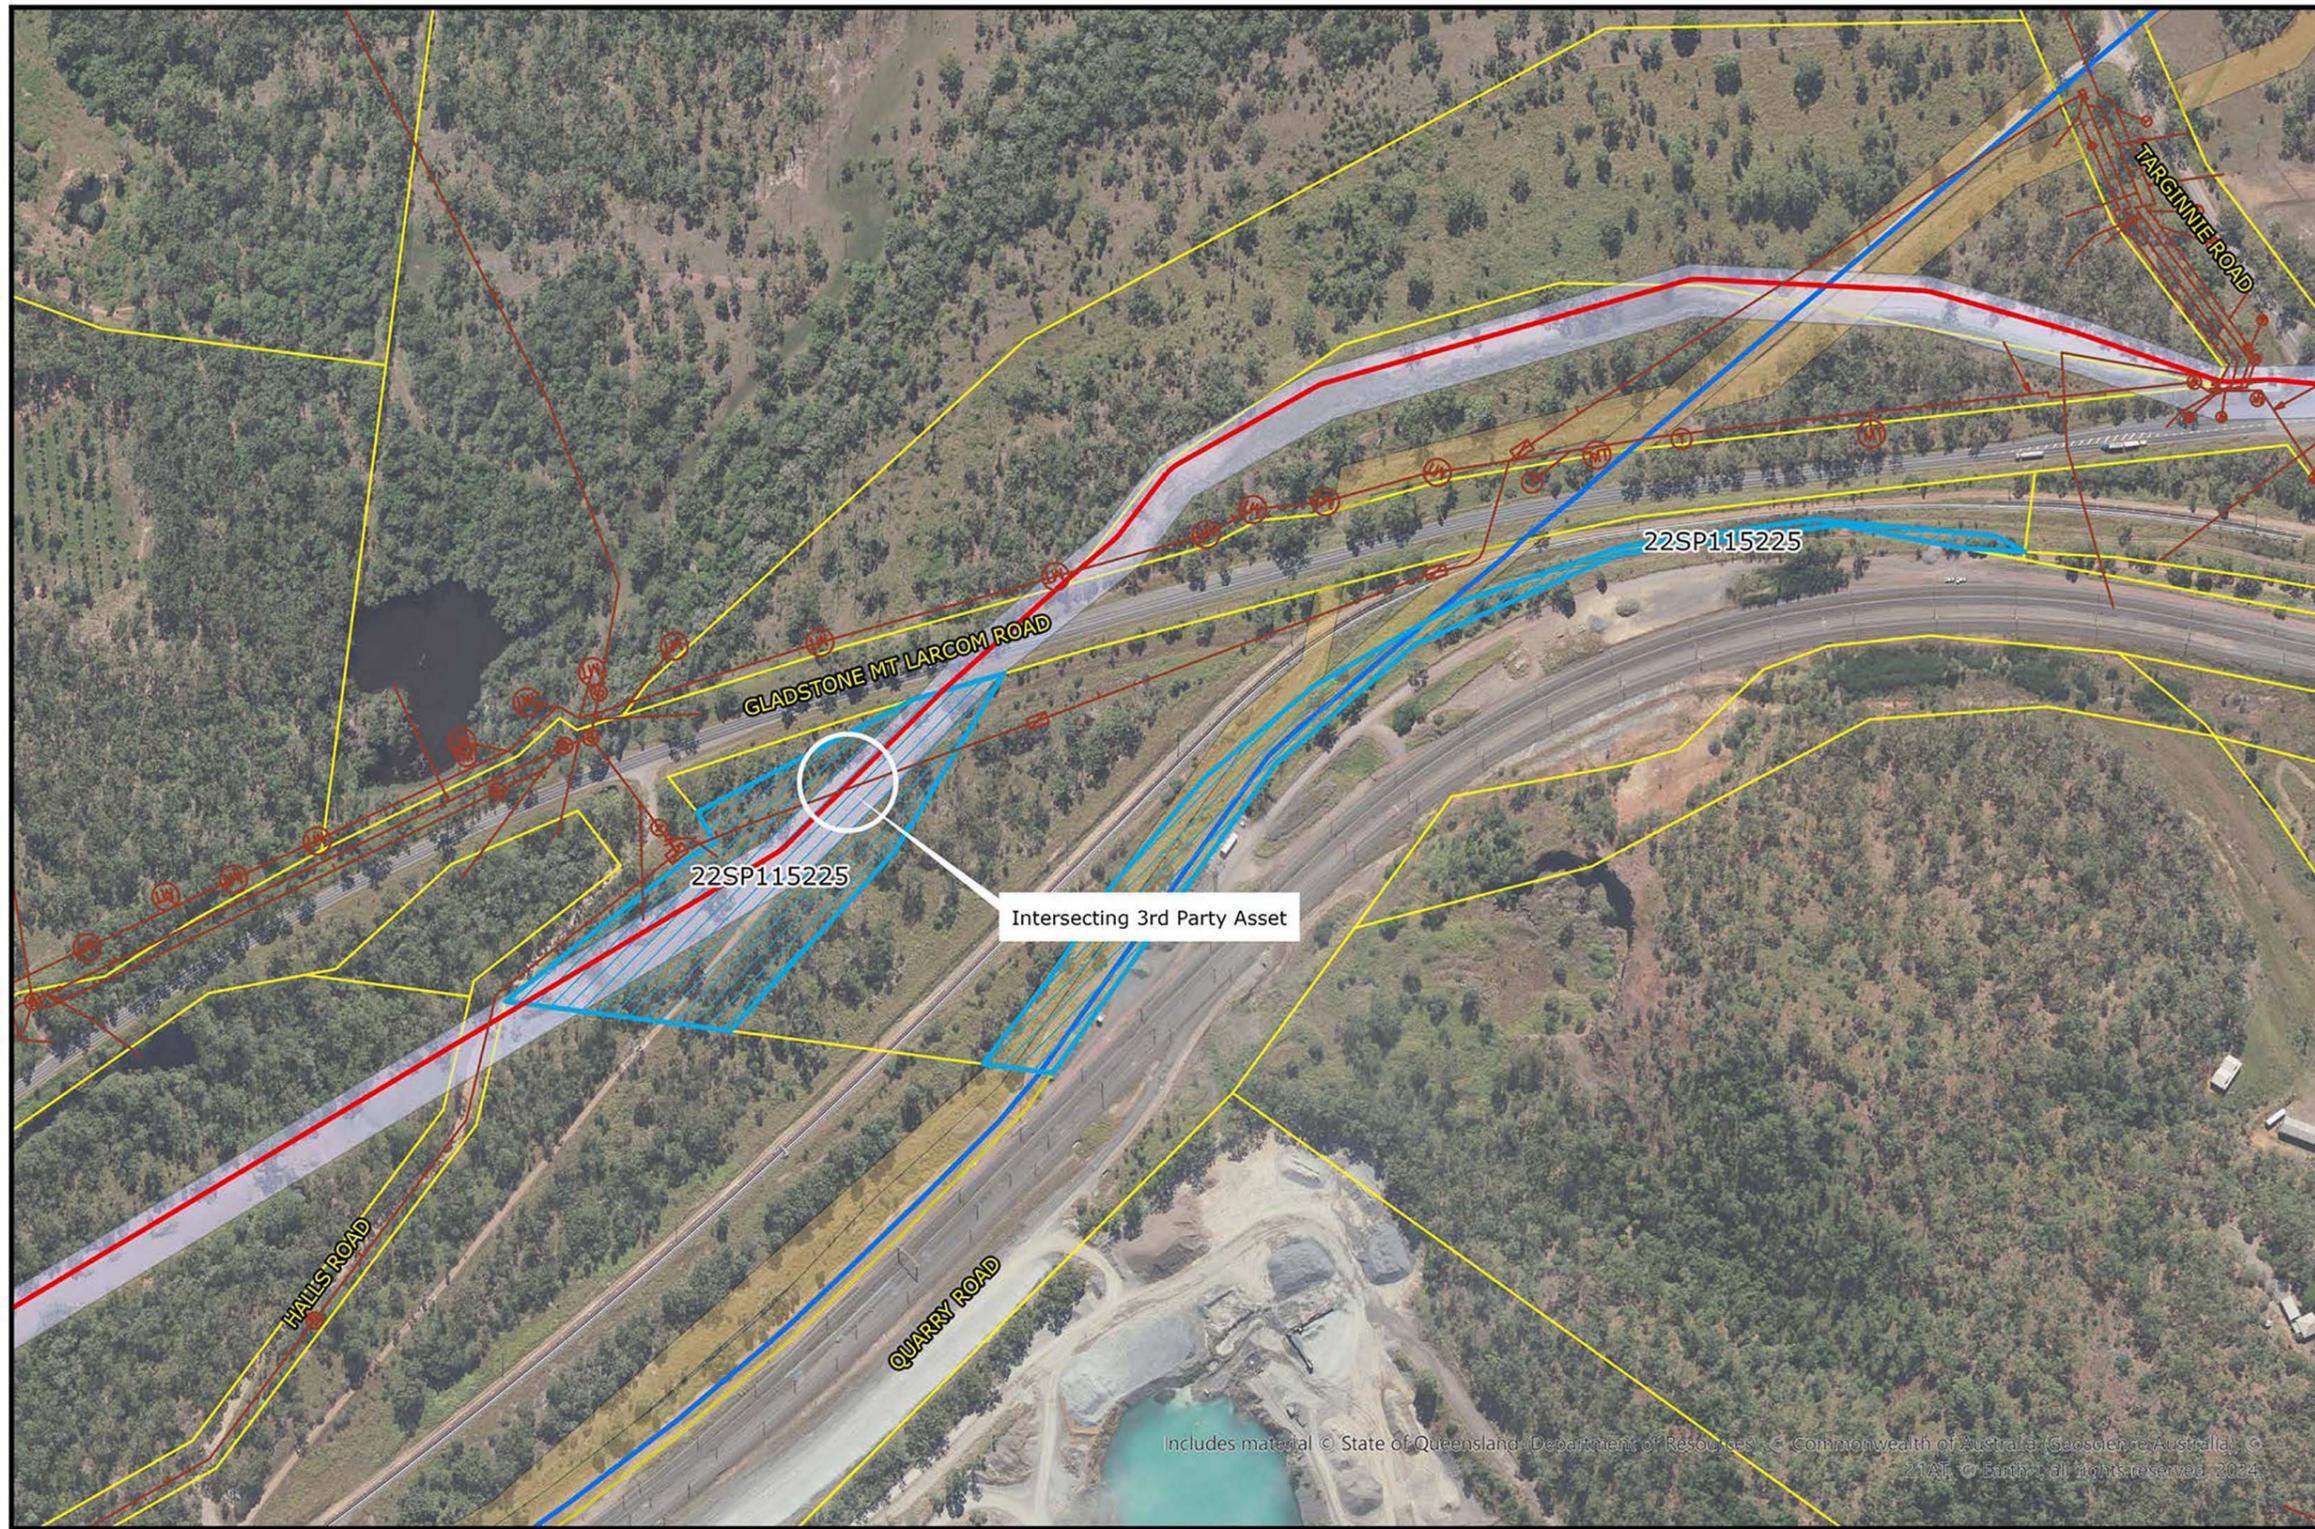
EAST END PIPELINE REPLACEMENT PROJECT
LAND SUBJECT TO LAND OWNERS REQUEST
LOT 22 ON SP115225

- East End Treated Water Pipeline
- Easement
- Property Boundary
- GSDA Right Of Way
- Fitzroy Gladstone Pipeline Coexist Alignment
- Lot 22 on SP115225
- Telstra Infrastructure

Telstra Infrastructure

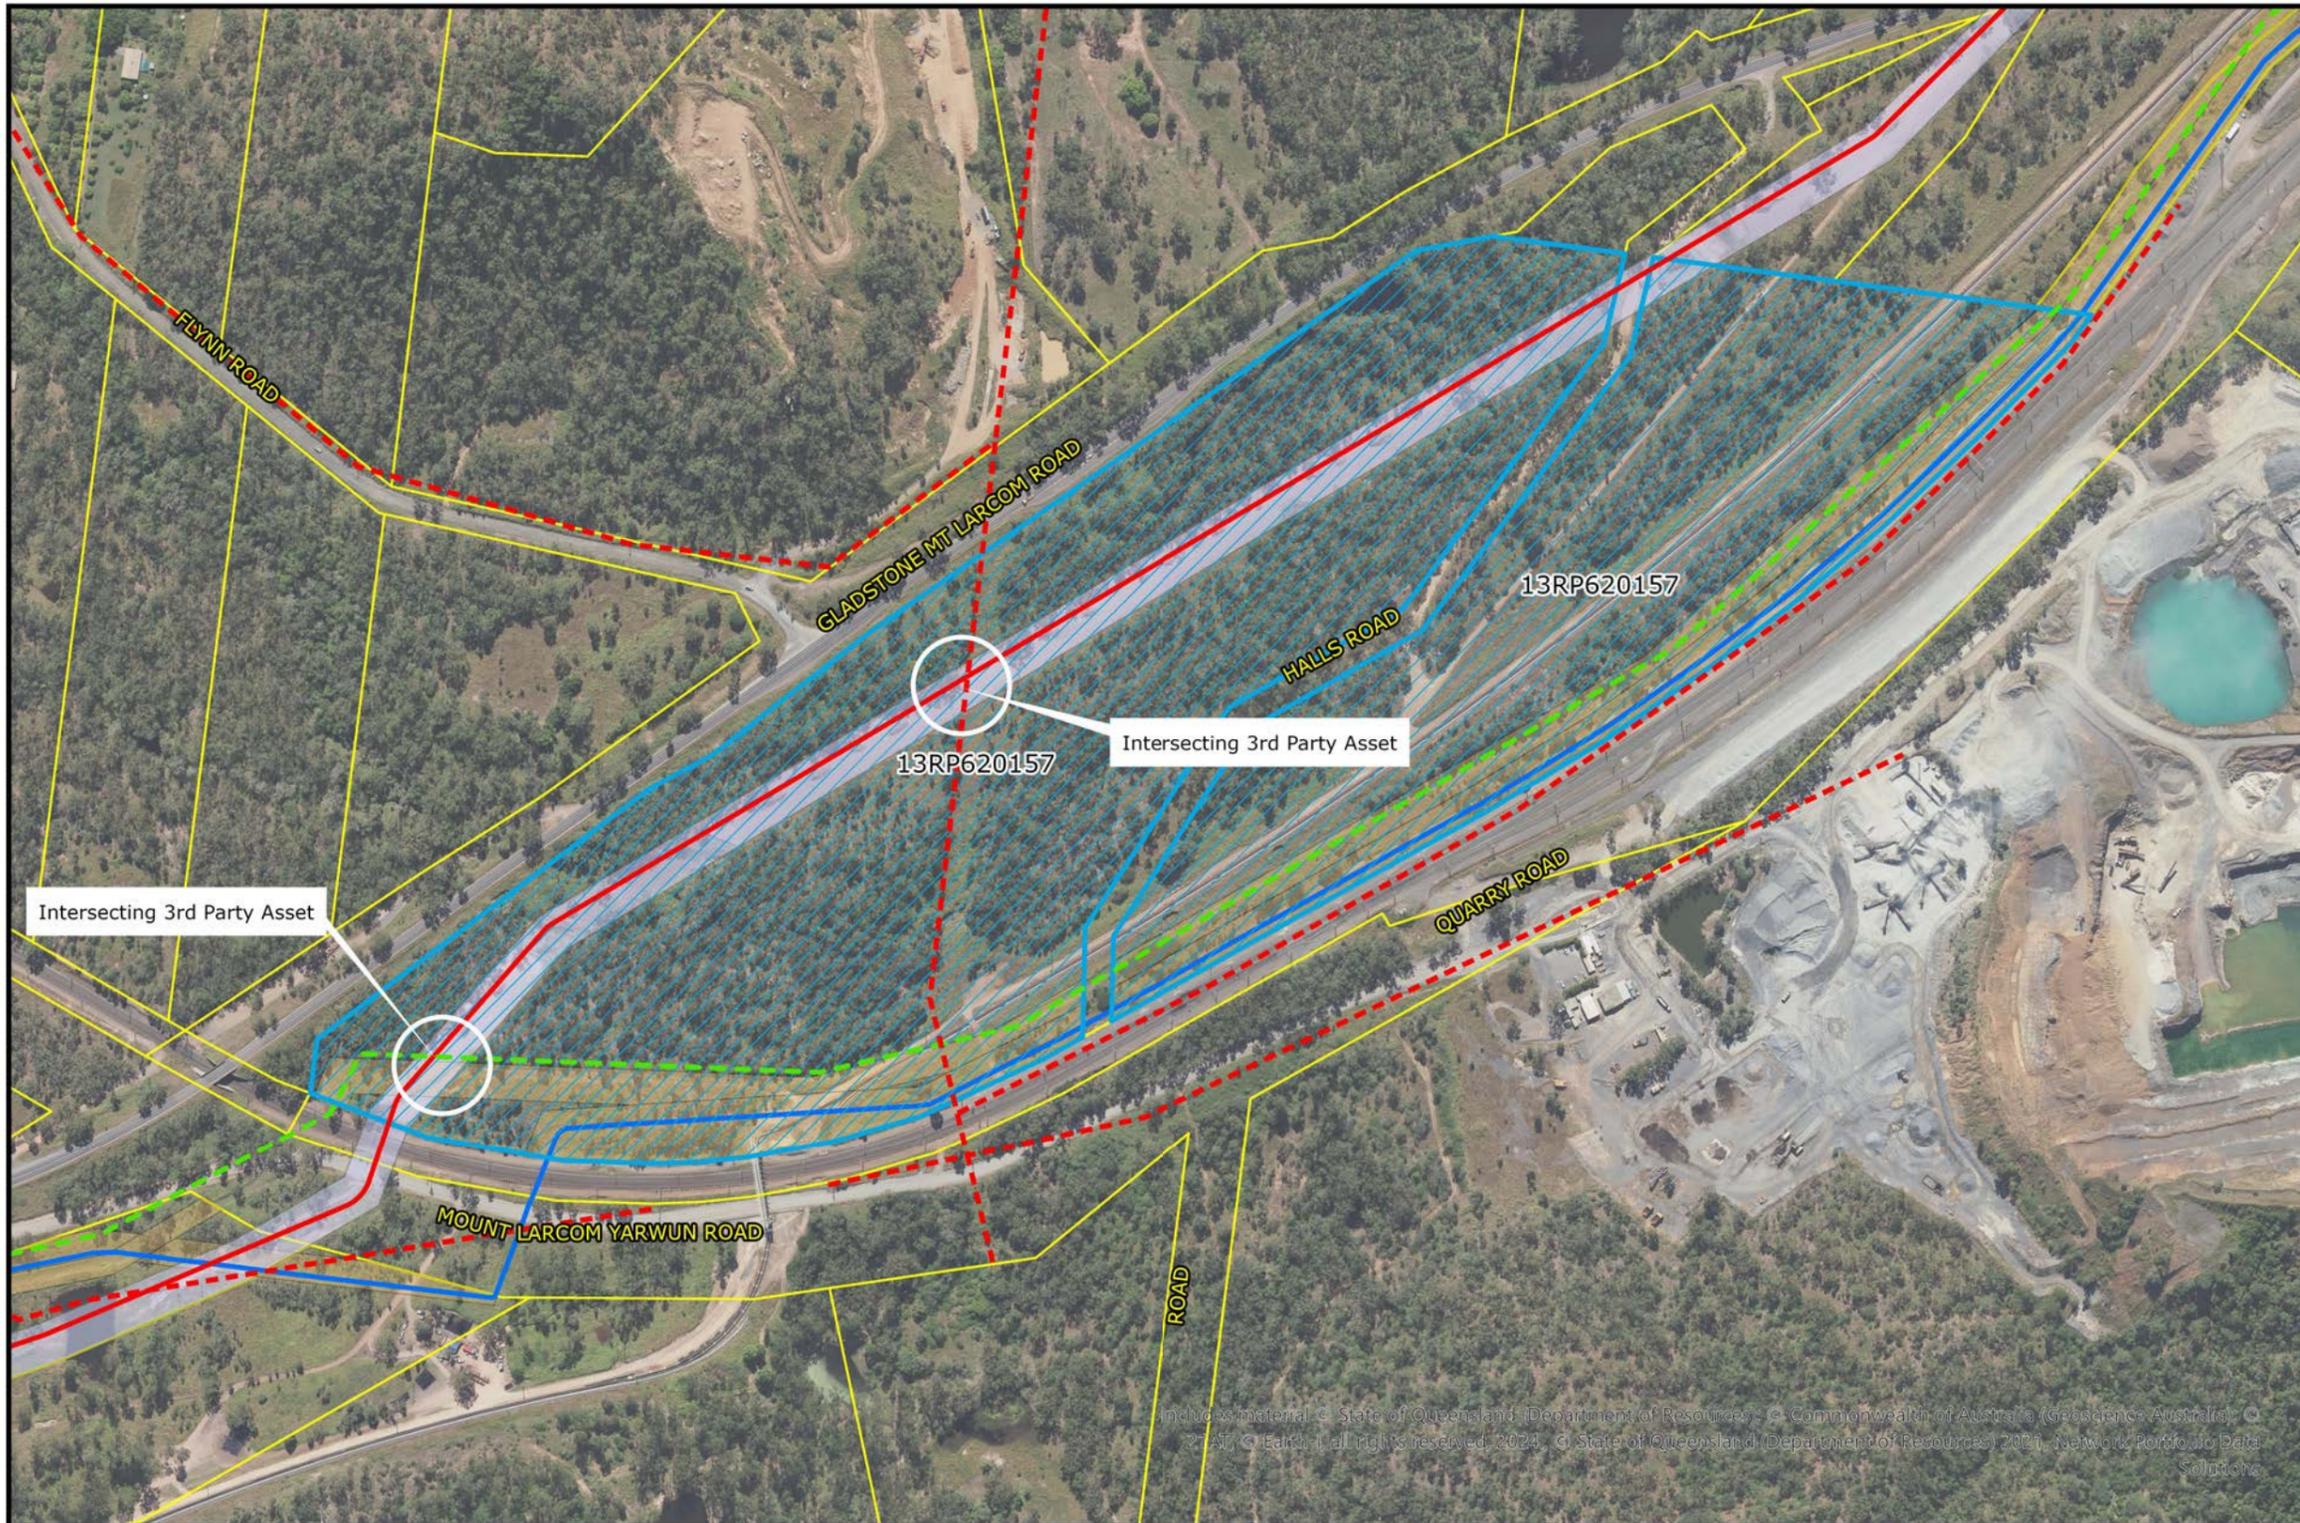
000-G-MAP-3316 Version 2 Date 10/10/2025

EAST END PIPELINE REPLACEMENT PROJECT
LAND SUBJECT TO LAND OWNERS REQUEST
LOT 13 ON RP620157

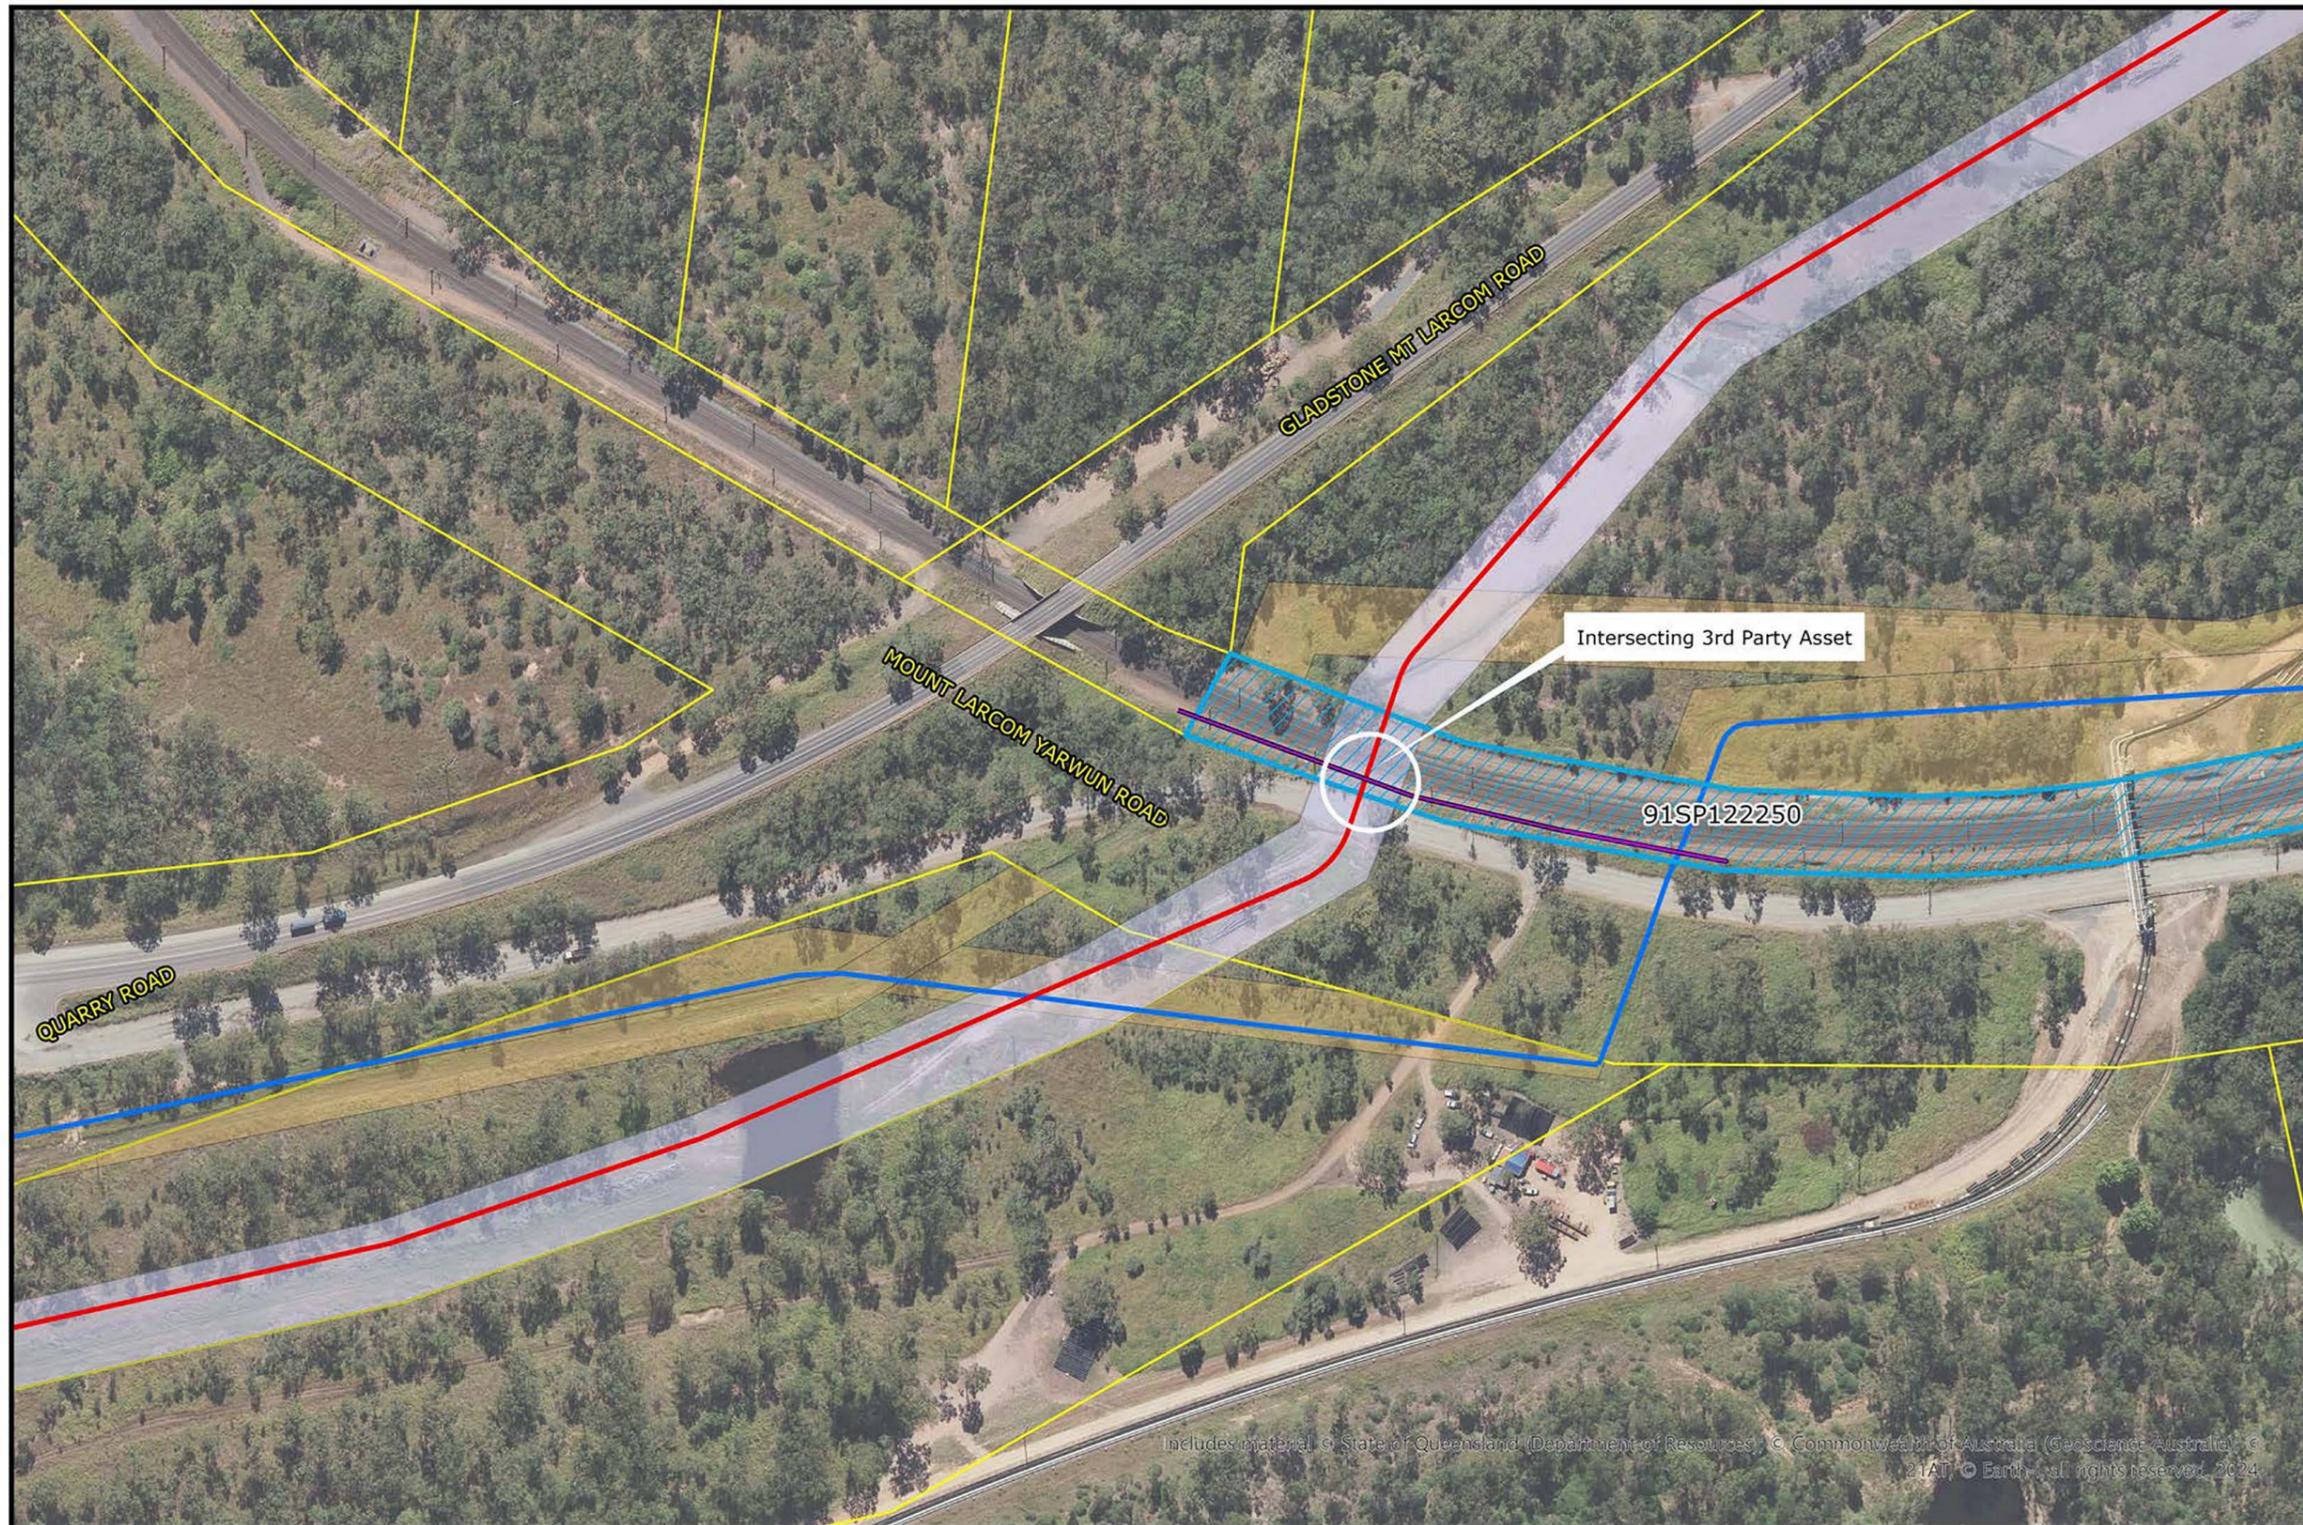
000-G-MAP-3317 Version 2 Date 10/10/2025

EAST END PIPELINE REPLACEMENT PROJECT
LAND SUBJECT TO LAND OWNERS REQUEST
LOT 91 ON SP122250

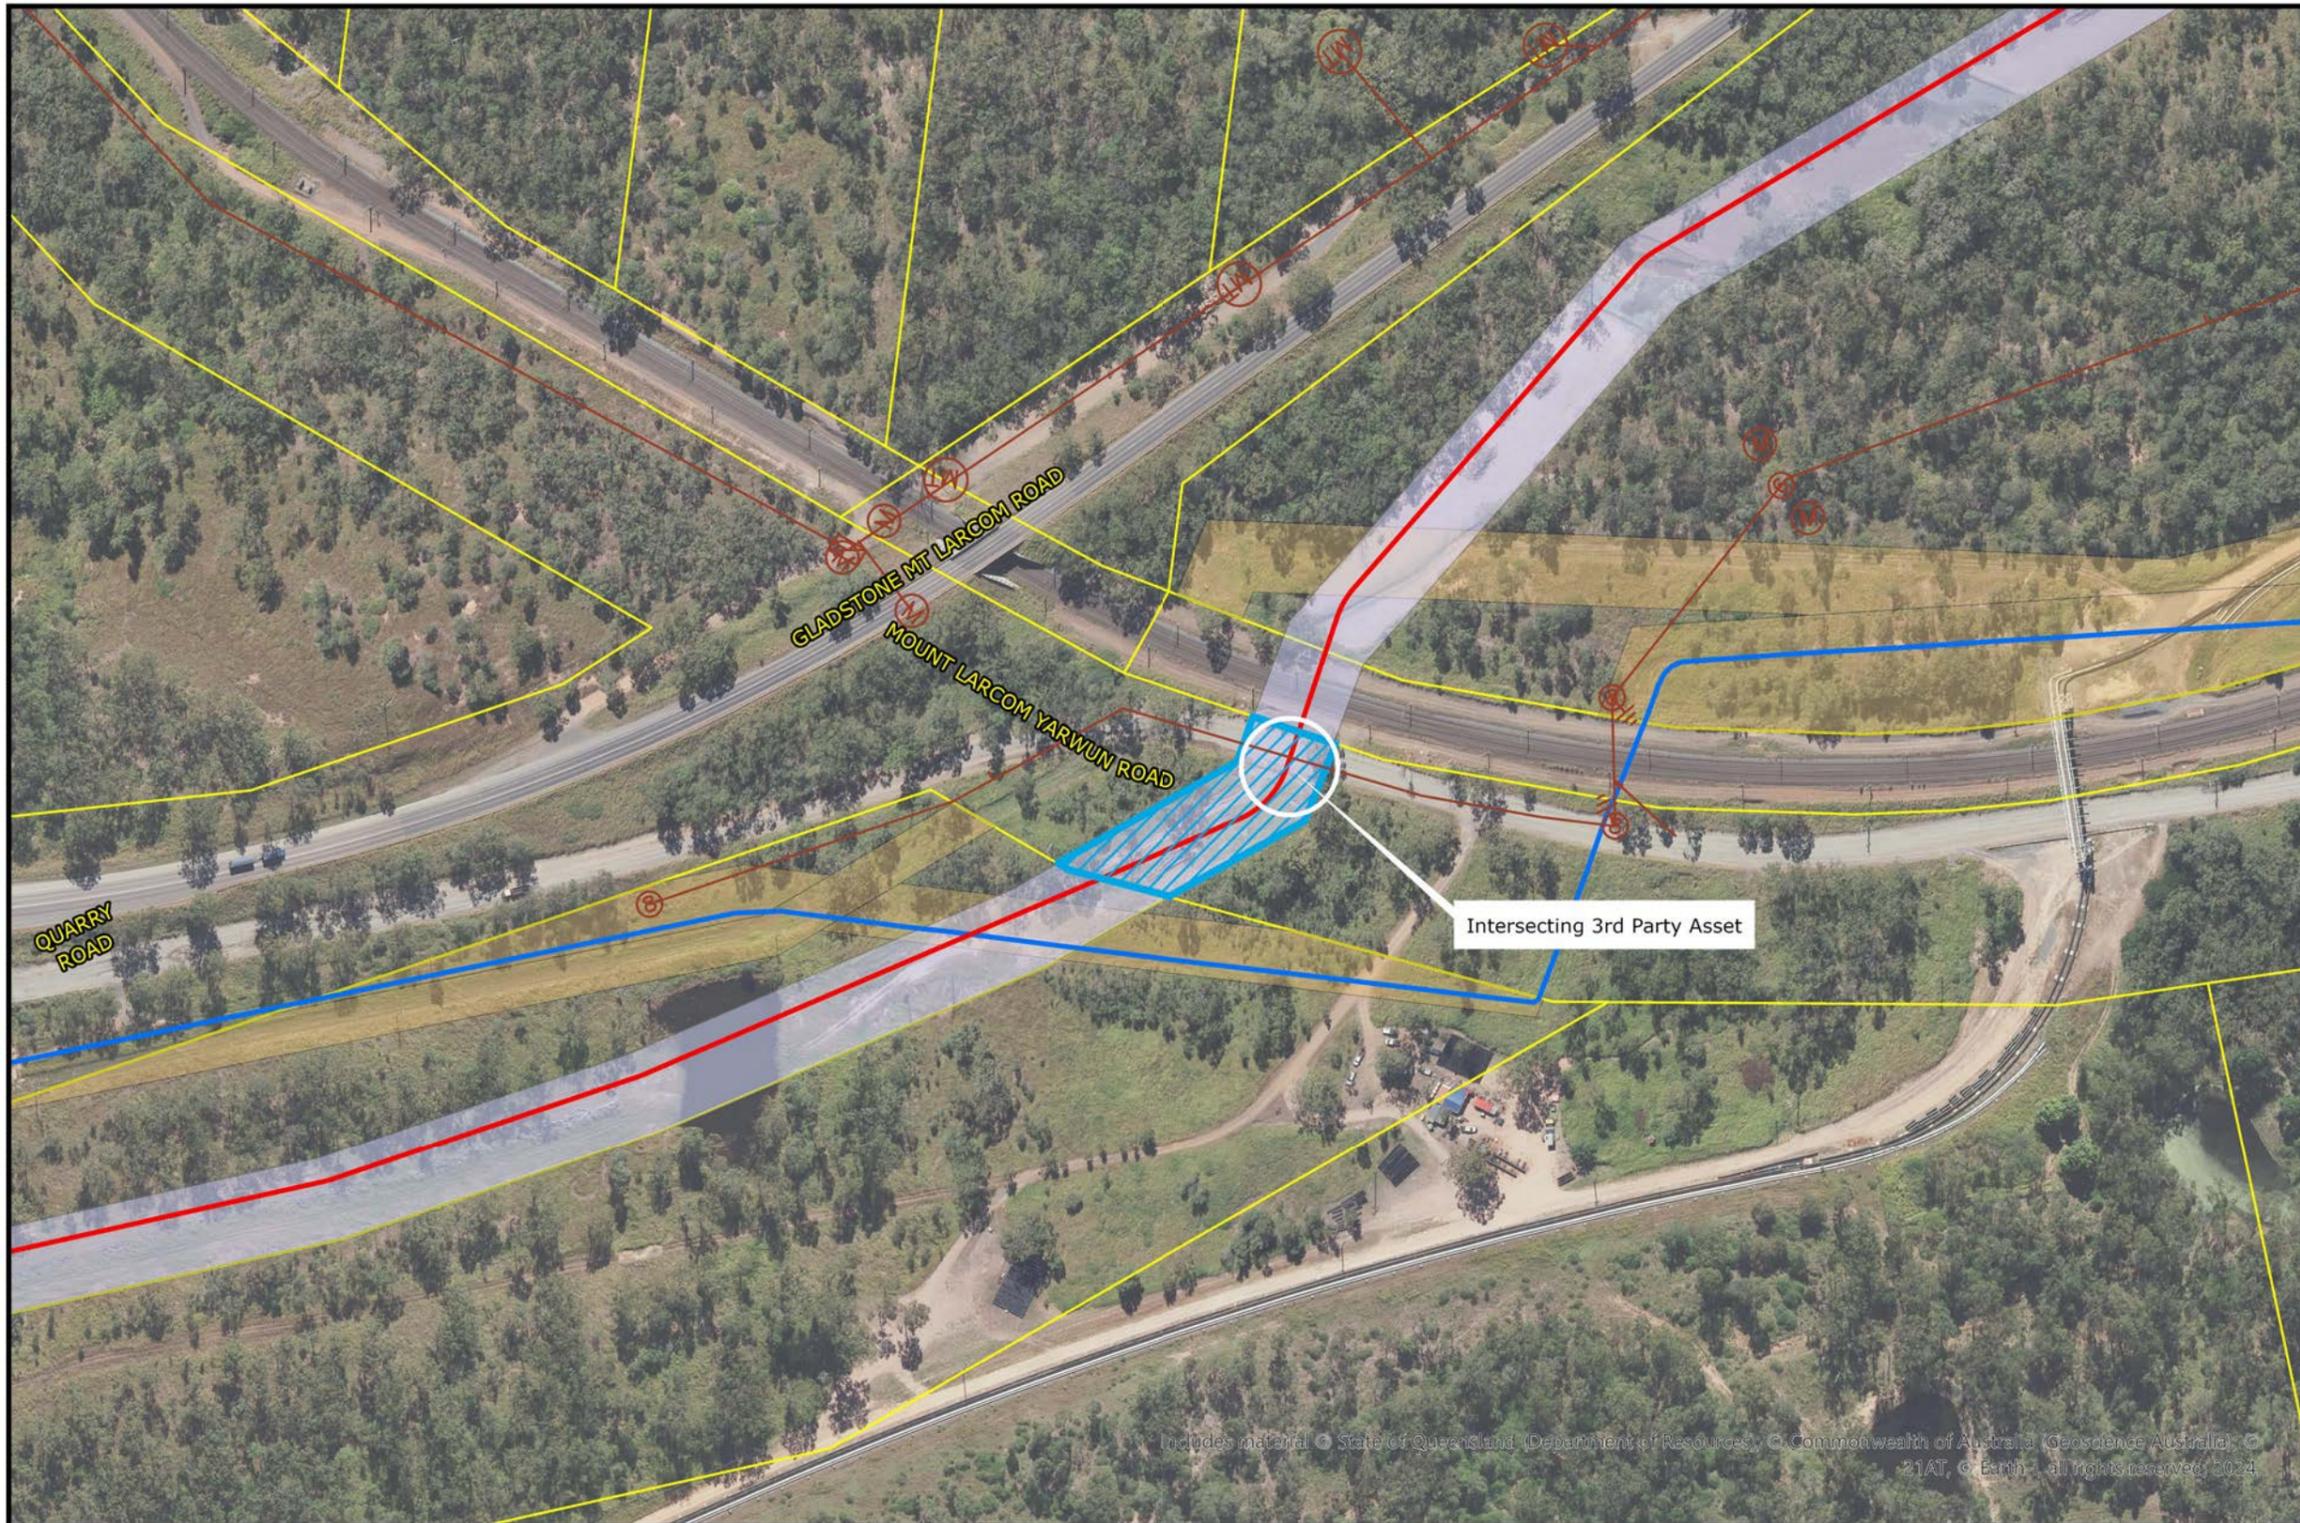
000-G-MAP-3318 Version 2 Date 10/10/2025

EAST END PIPELINE REPLACEMENT PROJECT
LAND SUBJECT TO LAND OWNERS REQUEST
GLADSTONE MOUNT LARCOM ROAD

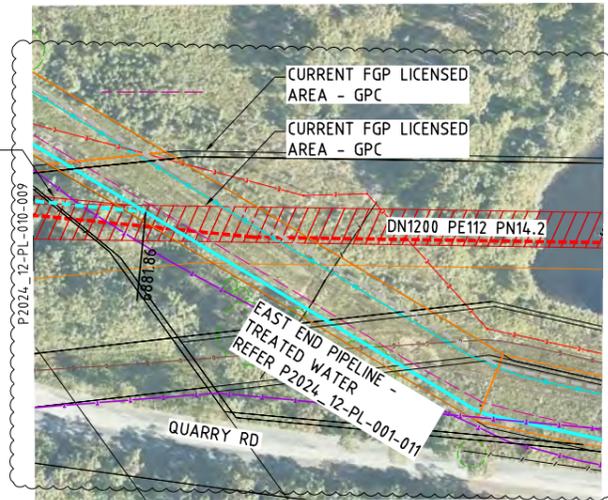
ADDITIONAL LICENSED AREA
REQUIRED: 501m²
